REPORT NO. 3564

CINCINNATI UNION TERMINAL COMPANY

IN RE ACCIDENT

APRIL 7, 1954

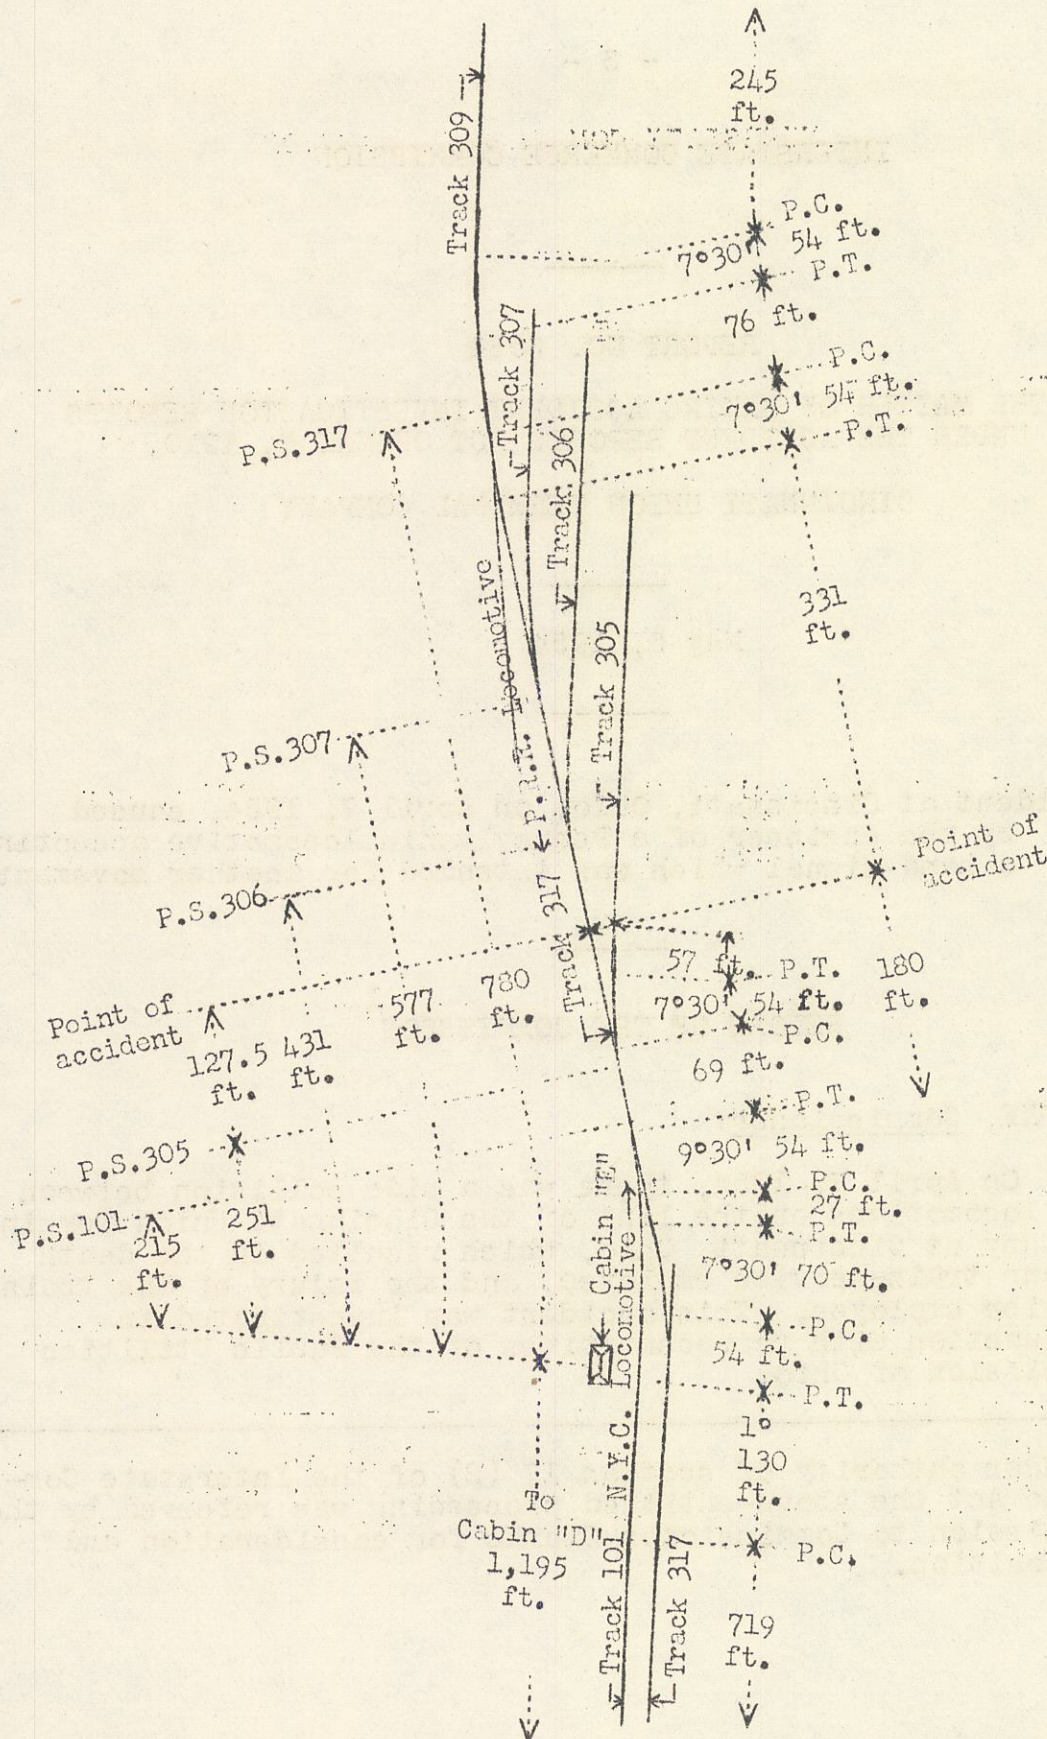
This accident occurred on the tracks of the Cincinnati Union Terminal Company. This company provides passenger station facilities for railroads operating into Cincinnati. Movements entering and leaving the passenger station are governed by interlocking signals. Two running tracks, designated from east to west as tracks Nos. 317 and 101, extend between Cabin "D", located immediately north of the north limits of the interlocking at the passenger station, and Cabin "E", 1,195 feet north of Cabin "D". Track No. 101 converges with track No. 317 at a point 215 feet north of Cabin "E", and from that point track No. 317 follows a northwesterly course to a junction with track No. 309 at a point 780 feet north of Cabin "E". Three engine-house tracks, designated from east to west as tracks Nos. 305, 306, and 307, diverge toward the north from track No. 317 at points, respectively, 251 feet, 431 feet, and 577 feet north of Cabin "E". The accident occurred at the fouling point between tracks Nos. 305 and 317, 127.5 feet north of the point-of-switch at the south end of track No. 305. From the south, via tracks Nos. 101, 317, and 305, there are, in succession, a tangent 719 feet in length, a 1° curve to the right 130 feet, a tangent 54 feet, a 7°30' curve to the left 70 feet, a tangent 27 feet, a 9°30' curve to the left 54 feet, a tangent 69 feet, a 7°30' curve to the right 54 feet, and a tangent 57 feet to the point of accident. From the north, via tracks Nos. 309 and 317, there are, in succession, a tangent 245 feet in length, a 7°30' curve to the left 54 feet, a tangent 76 feet, a 7°30' curve to the left 54 feet, and a tangent 331 feet to the point of accident and 180 feet southward. The grade is 0.28 percent descending northward at the point of accident.

New York Central steam locomotive 3108, headed southward and moving in backward motion, moved from Cabin "D" to Cabin "E" on track No. 101. At Cabin "E" it was routed from track No. 101 to track No. 305, via track No. 317, and while it was moving northward at an estimated speed of 5 miles per hour it collided with a Pennsylvania locomotive at the fouling point between tracks Nos. 317 and 305, 127.5 feet north of the point-of-switch at the south end of track No. 305.

The Pennsylvania locomotive consisted of Diesel-electric units 5872A and 5842B, coupled in multiple-unit control. This locomotive, headed northward and moving in backward motion, entered track No. 317 from track No. 309, and while it was moving southward at an estimated speed of 5 miles per hour it collided with locomotive 3108.
